**DEPARTMENT OF TRANSPORTATION**

Contract #: 04-0120F4Cty: SF/ALA Rte: 80 PM: 13.2/13.9File #: 99.28**WELDING INSPECTION REPORT****Resident Engineer:**Pursell, Gary**Address:** 333 Burma Road**City:** Oakland, CA 94607**Report No:** WIR-016488**Date Inspected:** 29-Aug-2010**Project Name:** SAS Superstructure**OSM Arrival Time:** 700**Prime Contractor:** American Bridge/Fluor Enterprises, a JV**OSM Departure Time:** 1900**Contractor:** Zhenhua Port Machinery Company, Ltd (ZPMC)**Location:** Shanghai, China**CWI Name:** Li Yang and Zhu Zhong Hai**CWI Present:** Yes No**Inspected CWI report:** Yes No N/A**Rod Oven in Use:** Yes No N/A**Electrode to specification:** Yes No N/A**Weld Procedures Followed:** Yes No N/A**Qualified Welders:** Yes No N/A**Verified Joint Fit-up:** Yes No N/A**Approved Drawings:** Yes No N/A**Approved WPS:** Yes No N/A**Delayed / Cancelled:** Yes No N/A**Bridge No:** 34-0006**Component:** OBG Trial Assembly**Summary of Items Observed:**

Orthotropic Box Girder (OBG) at Trial Assembly Areas

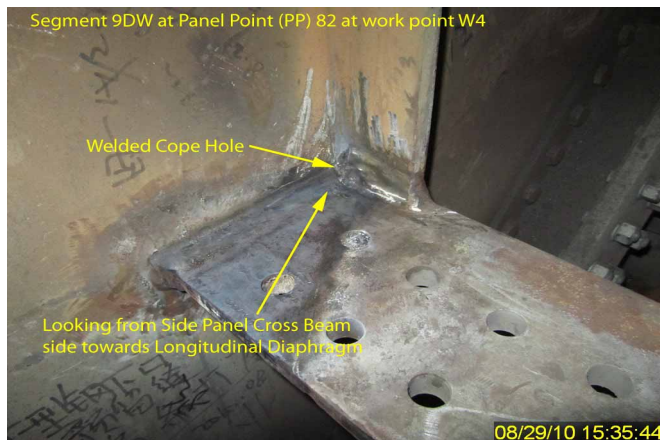
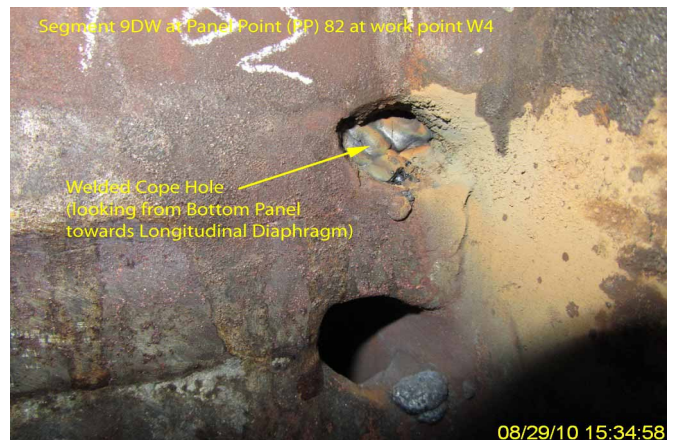
This Quality Assurance (QA) Inspector wrote an Incident Report for welded cope hole at Longitudinal Diaphragm flange to Floor Beam flange termination area as per approved shop drawing FB27A it shall have a radius of R30mm at PP 82 for Segment 9DW at work point W4. Please reference the Incident Report 04-0120F4\_TL-15\_B278\_08-29-2010\_LD\_FB Flange Welded Cope Hole\_9DW at PP 82\_at W4 dated August 29, 2010.
